Coal Mine Fatal Accident 2006-47

Operator:	Dana Mining Company Inc
Mine:	Prime No 1
Accident Date:	December 17, 2006
Classification:	Fall of Roof or Back
Location:	Dist. 3, Monongalia County, West Virginia
Mine Type:	Underground Coal Mine
Employment:	63
Production:	4,000 Tons/Day

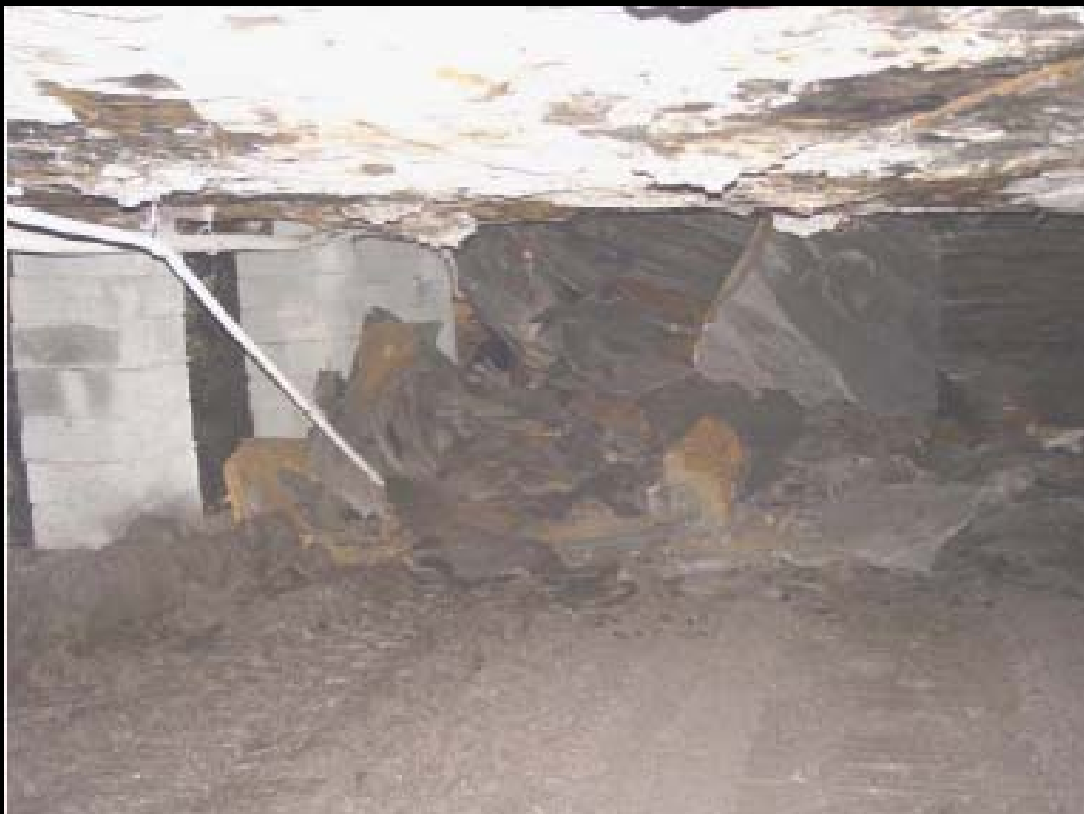
On December 17, 2006 at approximately 7:30 p.m. a 26-year old mechanic was fatally injured in a roof fall. The victim and 2 co-workers were traveling through the No. 18 block intersection (No. 2 entry) on a rubber tire personnel carrier when the top began to work and fall. The fall was approximately 28

feet long, 20 feet wide and 5.5 feet thick. The roof fall appears to have resulted from several geological conditions present in the No. 18 crosscut area of the mains. First, ground water inflow over time weakened the rock in the immediate roof susceptible to moisture. The roof fall appears to have started on the inby side of the intersection where moisture had caused weathering or weakening of the immediate roof and progressed along a vertical fracture that cut through the intersection, parallel with the entry.

Root Cause: The standards, policies and administrative controls in use at the mine did not equip mine management or miners to recognize the geological conditions (ground water inflow, alternating layers of weathered and fragmented rock, N 50°W trending joint) which contributed to the roof failure.

Corrective Action: Examiners and miners were provided additional training in the recognition of adverse geologic conditions. The approved roof control plan was updated to supplement roof support in the regularly traveled haul road intersections from the No. 1 belt head to the No. 2 belt tail piece. Supplemental support consists of a minimum six cable bolts, 8-14 feet and 6 foot fully grouted roof bolts will be installed with 18 inch by 18 inch roof mats. The provision of supplemental support also was extended to all regularly traveled haul road intersections in the travel entry where adverse geologic conditions are recognized.
